Berryman

November 20, 2018

**Re: Robert Walker and Brandy Newsom,
Plaintiffs
v.
USAA Casualty Insurance Company,
Defendant
United States District Court
Western District of Oklahoma
Case #: CIV-17-752-D**

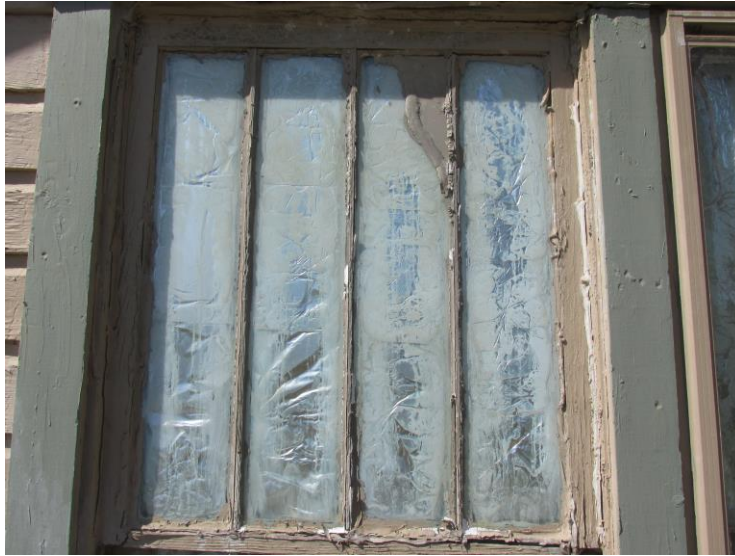
1. The home's exterior presented evidence of considerable wear, tear and deferred and/or improper maintenance that challenged the integrity of the home's exterior envelope. They represent likely pathways for water intrusion from time to time. Such evidence includes, but is not limited to:
 - Dilapidated windows.

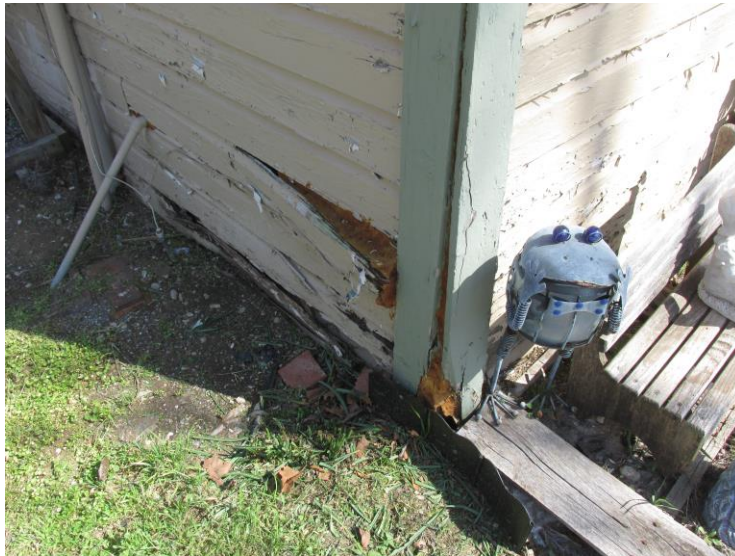
- Breaches in the exterior siding and also some attempts to seal breaches with expandable foam.

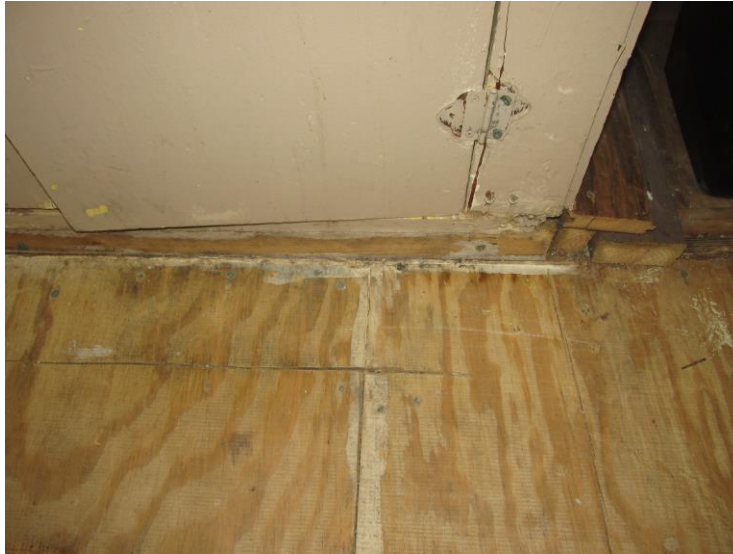
- Localized staining on the plywood in front of the lower sink cabinet on the north wall indicative of a chronic contact with moisture.

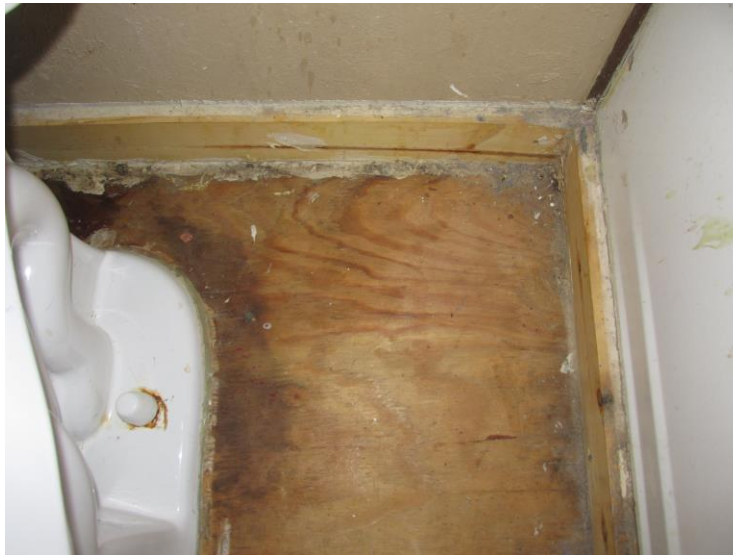
- Localized staining on the plywood in and around the bathroom toilet and wet wall of the tub. Again, this is indicative of multiple episodes of exposure to moisture.

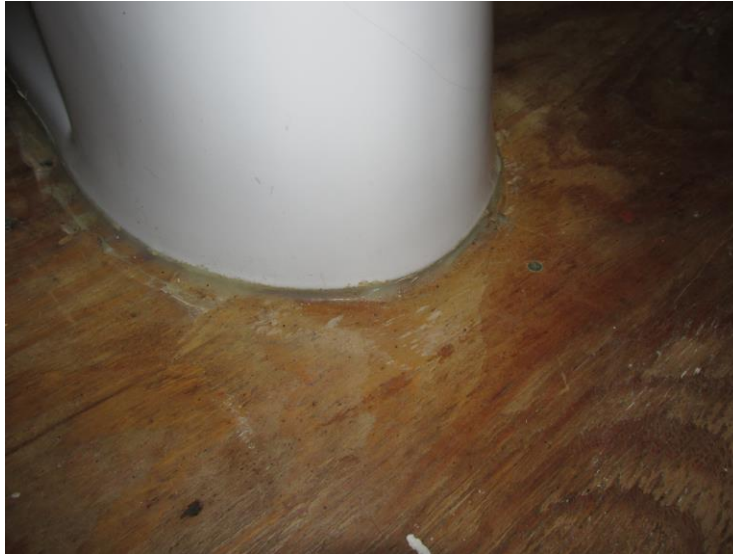
- The living room and master bedroom floors were approximately 3.5" above the remainder of the home.
- It appeared that the failed wax ring seal at the base of the toilet had been addressed since the toilet was first seen by USAA adjuster Phillips.¹³

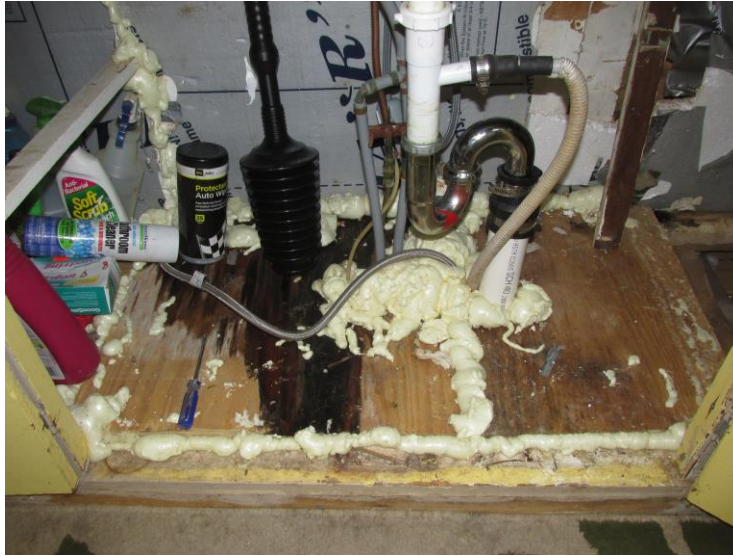
- Kitchen countertops were approximately 35" above the floor and in a state of disrepair. Pieces of the countertop edge were broken and missing. The countertop was not sealed properly to the backsplash. The underside of the countertop showed evidence of long term exposure to wetting.
- The floor of the sink cabinet had been removed and then covered with an access panel. Water discharge was ongoing.

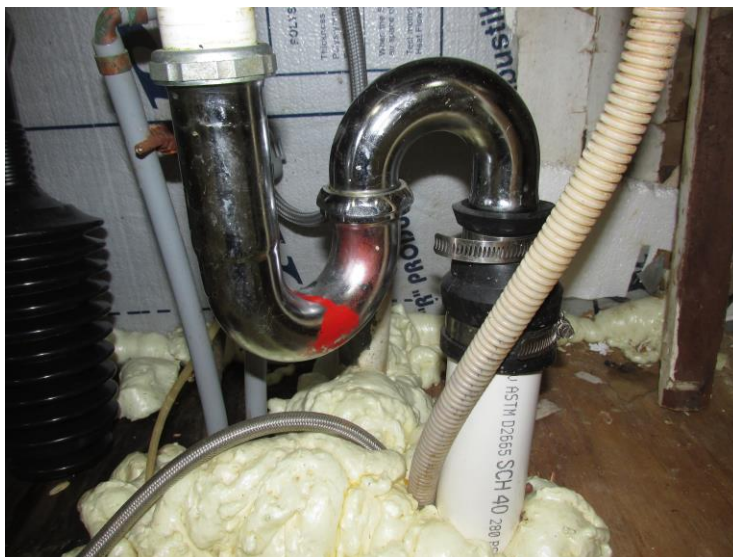
- The sink drain plumbing was improperly constructed and the sink had no vent. These elements served to restrict drainage. They are contrary to building code and good workmanship standard.

¹⁶ I observed the kitchen sink was not plumbed properly. The plumbing drain had an “illegal trap” and there was no plumbing vent. These latent defects are known to cause a plumbing system to drain slowly and clog more readily. Also, they allow all water to be pulled from the trap as the line drains. This allows sewer gas to escape into the interior of the home. This likely caused the smell the Plaintiffs encountered when they returned from their trip.

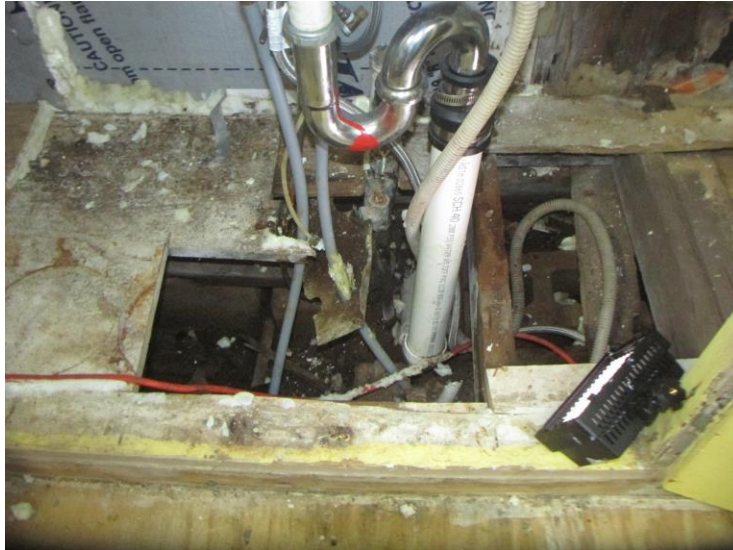
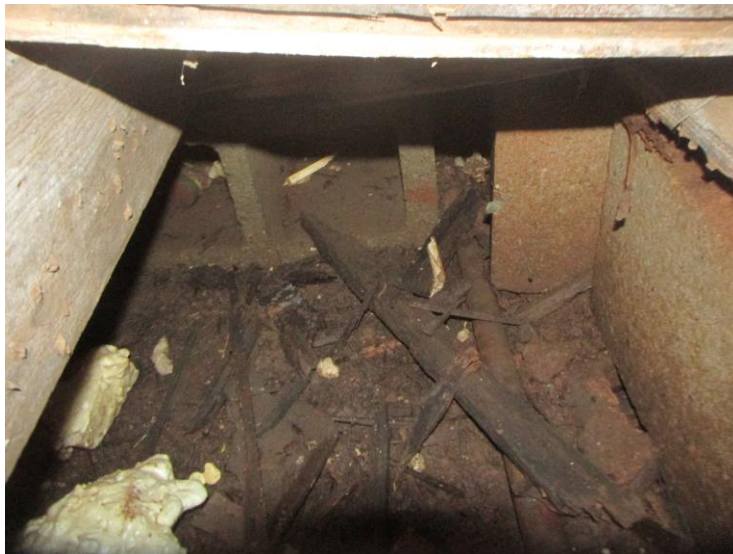
- The dishwasher was installed improperly. Its discharge hose has no anti-siphon loop.
- The sink drained slowly. I ran water into the sink for approximately 2 minutes after which the sink began to fill with water. I stopped the water and in a matter of a few minutes the backed-up water slowly disappeared into the drain.
- The cabinet access panel was removed. Typically, there would have been subfloor underneath, but instead, access to the crawlspace was readily open. I immediately detected heavy humidity escaping from the crawlspace. The area underneath was

saturated with moisture. I saw rotten and disintegrated wood structural members, wet CMU, rusted conduits, and rusted corrugated metal. I observed where the kitchen sink PVC drain line exited through the crawlspace's north perimeter.

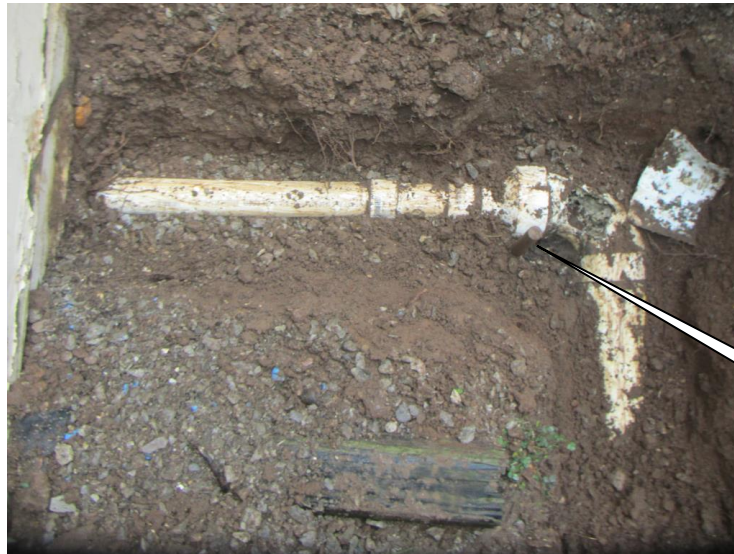
Metal stake
present

- Water continued to drain in the line as the camera made its way down the line. The camera encountered a blockage, i.e. dead-ended, that would not allow it to pass.
- As the camera moved toward the dead-end point, it submerged in liquid present in the line that was still in the process of draining.
- The kitchen drain line was then excavated immediately outside the the north kitchen wall. I observed the newer extension of 2" PVC pipe installed by Dismuke leading to a 4" Schedule 40 PVC line.
- I encountered a metal stake had been driven into the ground in the past in a manner that appeared to be a marker for the 90 degree elbow in the line.

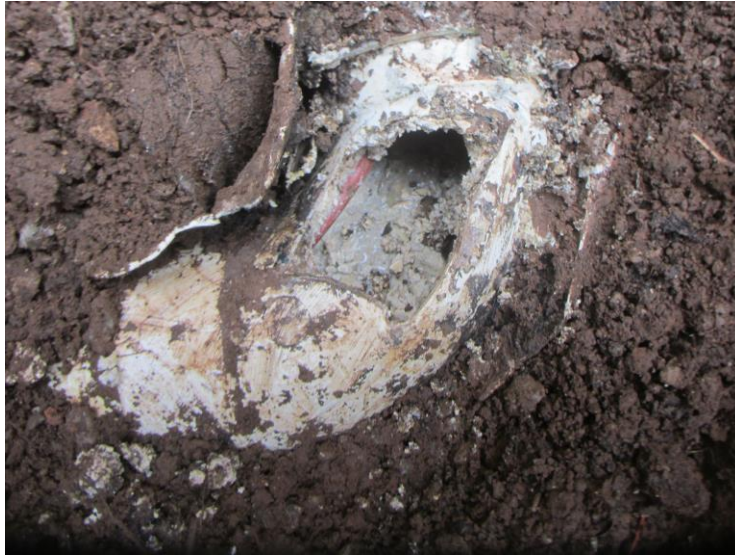
- The 90 degree elbow was then exposed. A hole had been cut into the side of the elbow in an unconventional manner and covered in a makeshift manner with what appeared to be a scrap piece of vinyl flooring. The characteristics and location of the hole suggests its purpose was to provide a “clean-out” opening for the insertion of a roto-auger to address obstructions in the line as they might arise from time to time.

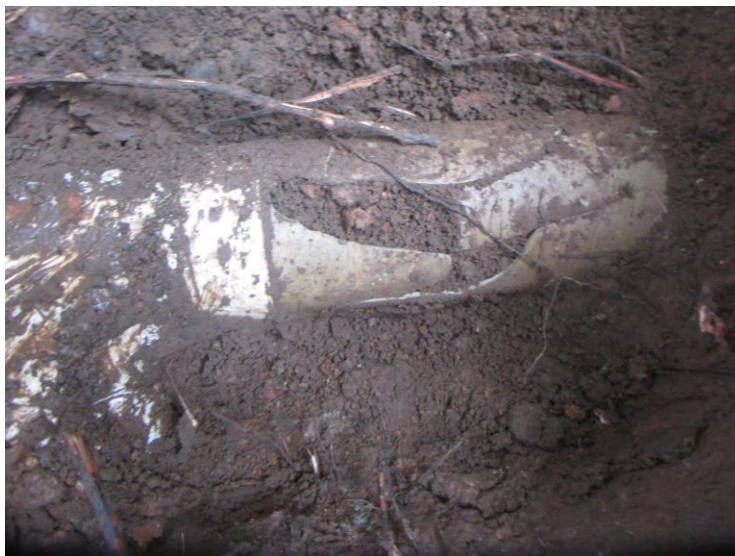
- Next, the kitchen branch was excavated at the dead-end point.
- The 4" Schedule 40 kitchen branch line coming from the kitchen transitioned into a Schedule 20 line and intersected a 4" line leading from another house to the north, thus forming a tee. A large fracture was observed in the Schedule 20 line just downstream from the tee intersection. Dirt, grease, and significant tree roots were observed occluding the line and restricting flow.

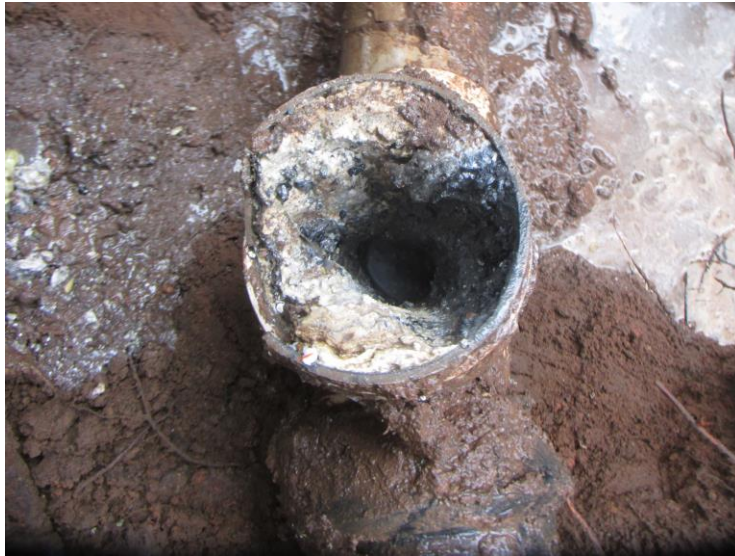
- The tee was excised and examined. The section of pipe leading from the Walker kitchen was approximately 50% occluded with grease.

- The volume of grease and tree root deposits observed takes considerable time to manifest itself to the degree observed.
 - The deposits are cumulative and caused drainage to become slower and slower over time. These slower draining conditions usually become noticeable to a homeowner and continue to become worse with time as the deposits accumulate.

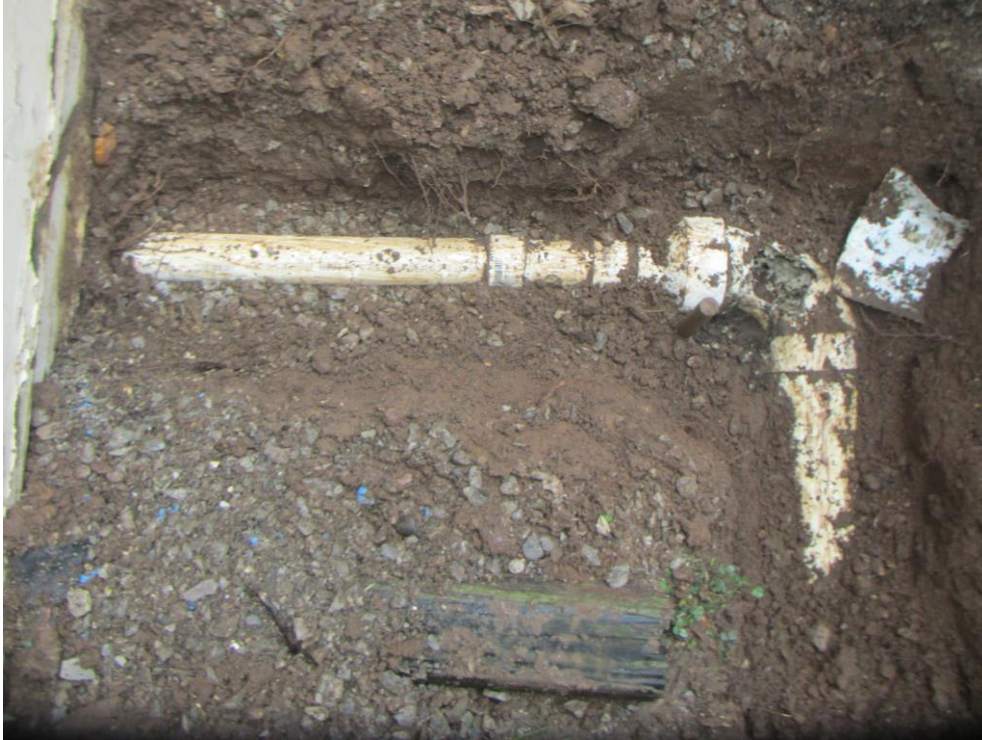
- 1.1. Based upon USAA's advice and with their approval, Walker engaged a local plumber to determine the cause of the plumbing back-up and reported discharge. This is an industry standard approach.
- 1.1.1. The plumber, Dismuke Plumbing (Dismuke), unstopped the kitchen sink and replaced the 2" drain line from the kitchen sink to the 4" drain line located underground. The work was done in the first couple of days following the reported date of loss, 9/25/16, and billed on 9/29/16.¹⁴ I observed this newly installed plumbing drain line during my 9/26/18 site visit:

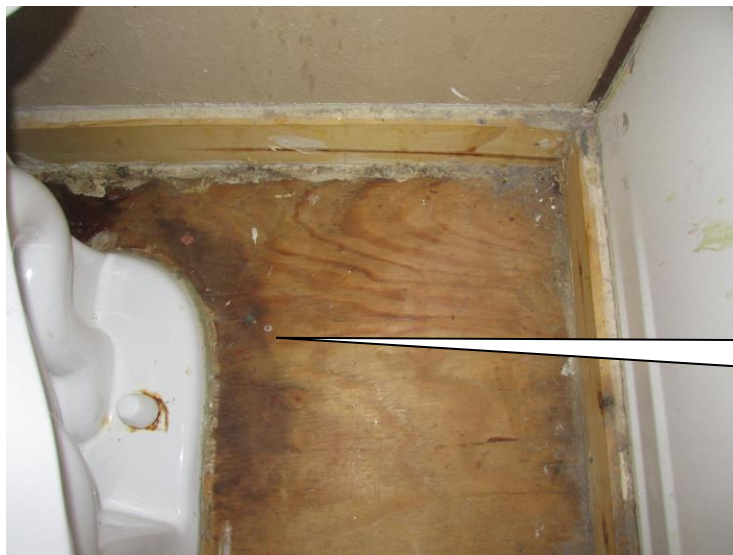
2.6. However, there is evidence that the wax ring seal at the toilet was deteriorated and allowing leakage of sewage during toilet use.²⁵

²⁵ A "wax ring" is installed at the base of a toilet, sandwiched between the toilet and the drain pipe to which it is connected. It creates a watertight seal; however, age and use, along with some elements of wear and tear, typically cause the seal to fail over time. In this case, maintenance must be performed to replace the wax ring.

- 2.10. The plywood subfloor showed signs of localized staining around the toilet and at the faucet end of the tub. The former appears to be the result of localized leaking at the fresh water valve and the failed wax seal at the base of the toilet. The latter suggests water bypassing the shower curtain as the occupants showered. I did not observe the more uniform stain pattern that would be indicative of a toilet overflow.

Localized
staining due to
failed wax ring

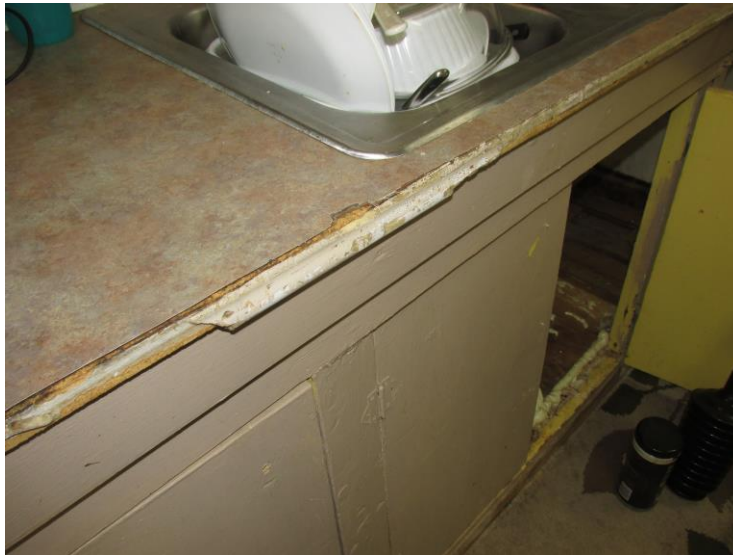
- Kitchen countertops. *As previously outlined in this report, the countertops would not have been impacted by a plumbing back-up at the sink. At any rate, kitchen countertops are made to get wet. Water from a sink, either fresh water or back-up water from a single event would not damage the countertops. I observed the countertops were in a state of disrepair from wear, tear and poor maintenance unrelated to Walker's claim.*
